APPENDIX B | ENHANCED CORRIDOR BUS STOP INVENTORY

The TDP team conducted a field inventory of amenities and site conditions at all existing bus stops the week of March 29, 2021 along the following three TDP enhanced corridors:

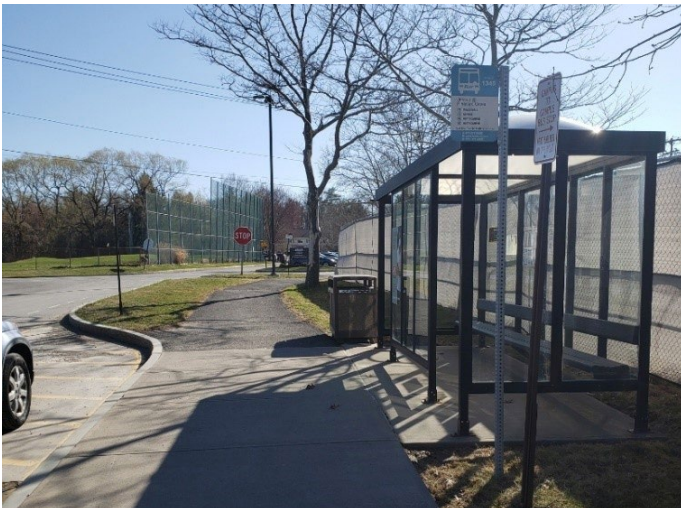
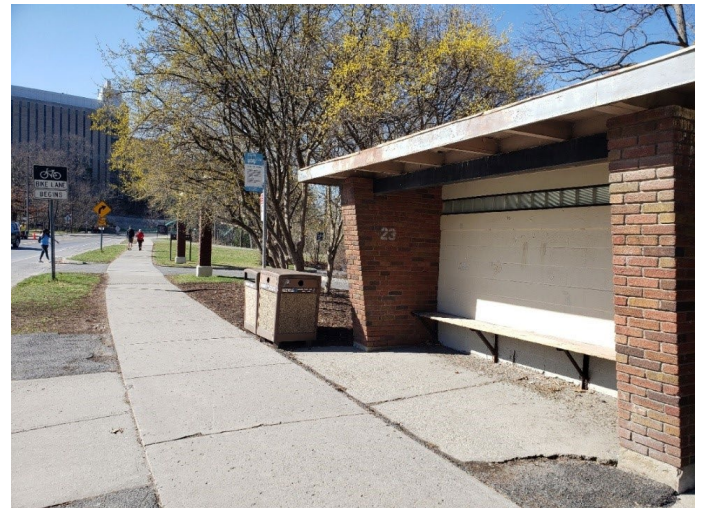
Figure 2: Examples of TCAT Shelters

The condition of the existing bus stop infrastructure was documented at each stop. Bus stop signs that were legible were classified as being in good condition; those that were illegible, showed signs of cracking, or were bent were classified as being in poor or damaged condition based on severity. Overall, almost all signs inventoried were in good condition, as they had recently been replaced during a system-wide sign replacement effort. Similarly, existing bus shelters that were intact and did not exhibit significant signs of wear were considered in good condition while those that showed signs of wear or were damaged (including graffiti) were classified as being in poor or damaged condition (Figure 2).

The condition of the infrastructure present at each of the 148 stops is summarized in Table 2. The majority (69%) of stops were identified by a pole-mounted signs only. A quarter (25%) of stops provided a shelter for waiting passengers. Only 5% of stops did not have a sign. The overwhelming majority of bus stop signs were determined to be in good condition. Overall, existing shelters were also found to be in good condition (92%).

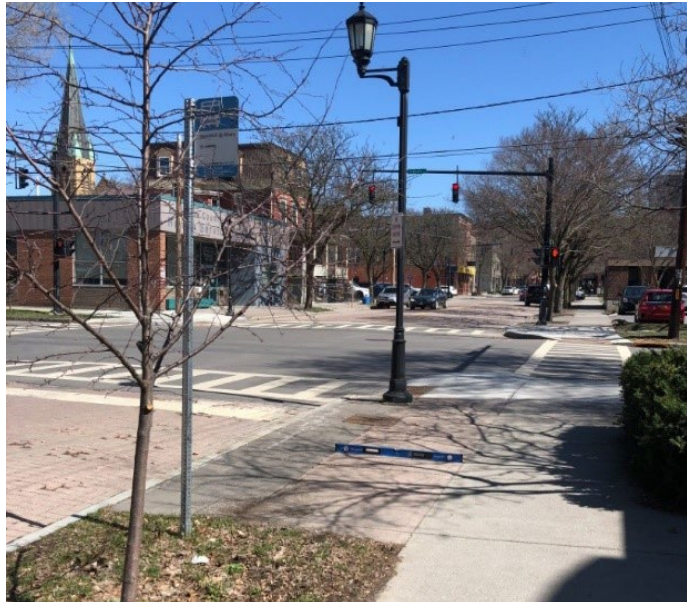
Figure 3: Examples of Sidewalk Conditions

In addition to the bus stop itself, it is important that passengers can access the stop via the sidewalk network. A qualitative assessment of sidewalk conditions adjacent to each stop was identified during the field inventory based on signs of surface distress. Sidewalks with little to no signs of cracking were classified as good while those with more extensive cracking and signs of distress were classified as poor. Stops that did not provide a sidewalk were classified as “sidewalk missing.” Figure 3 provides examples from the inventory. The condition classifications were kept overly broad (“Good”/ “Poor”) to minimize the impact of surveyor opinion on the findings. Table 3 summarizes the overall findings of sidewalk conditions at existing bus stops.

inventoried bus stops. Those stops found to be in poor or damaged condition should be evaluated for prioritization for capital improvements in future projects. A quarter (25%) of inventoried stops were found to have no sidewalk at all. Most of these stops are located along Dryden Road, which serves primarily rural areas. While construction of new sidewalk is not the responsibility of TCAT, consideration should be given to the locations of these stops as to whether pedestrian improvements can be accommodated. Potential low-cost treatments have been developed as template recommendation packages and included in other sections of this plan.
